**CORROSION CONDITION SURVEY  
OF U1020 MONTANA AVENUE OVERPASS-BILLINGS  
FOR  
MONTANA DEPARTMENT OF TRANSPORTATION  
WJE No. 2000.2547  
November 27, 2000**

CORROSION CONDITION SURVEY  
OF U1020 MONTANA AVENUE OVERPASS-BILLINGS  
FOR  
MONTANA DEPARTMENT OF TRANSPORTATION  
WJE No. 2000.2547  
November 27, 2000

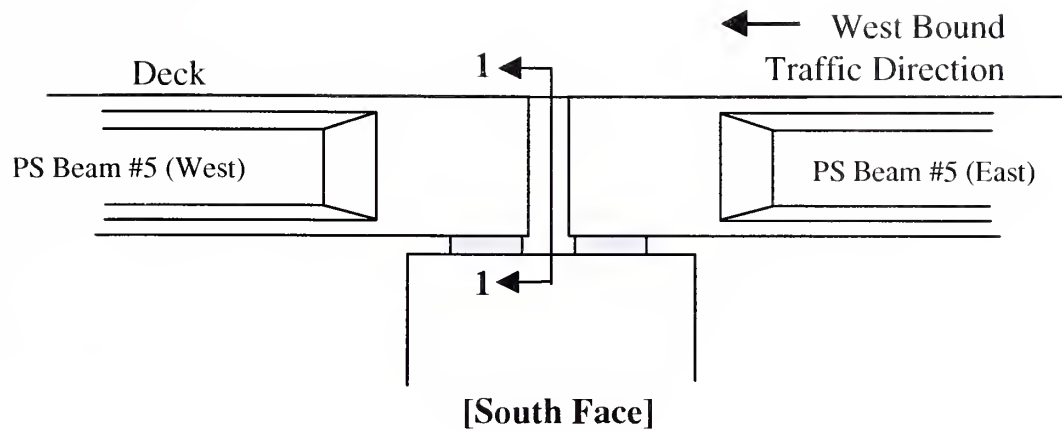
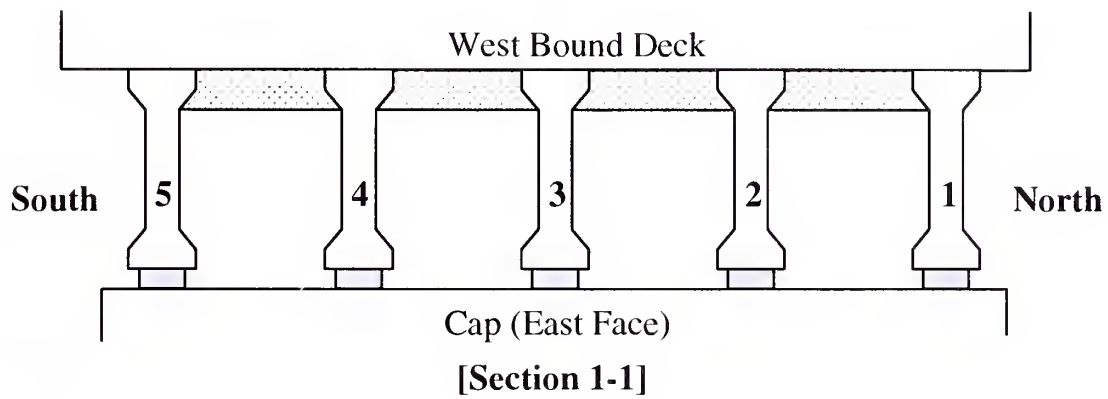
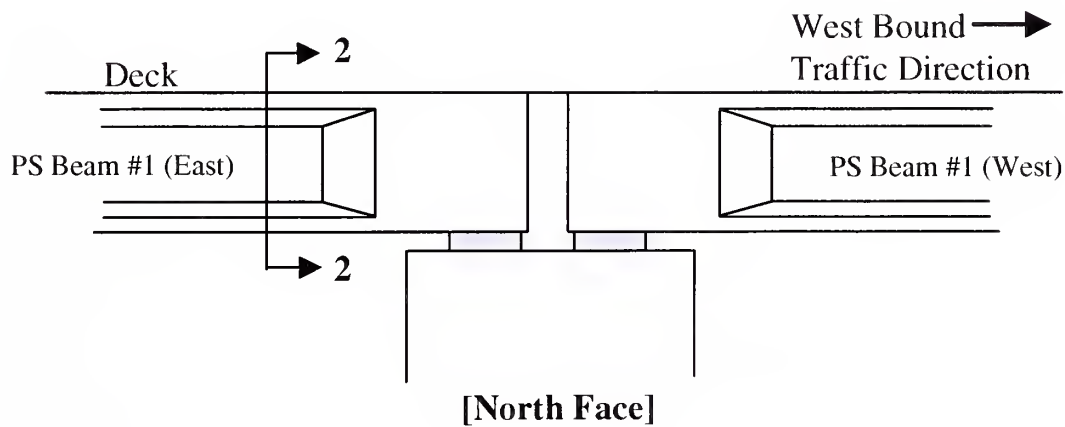
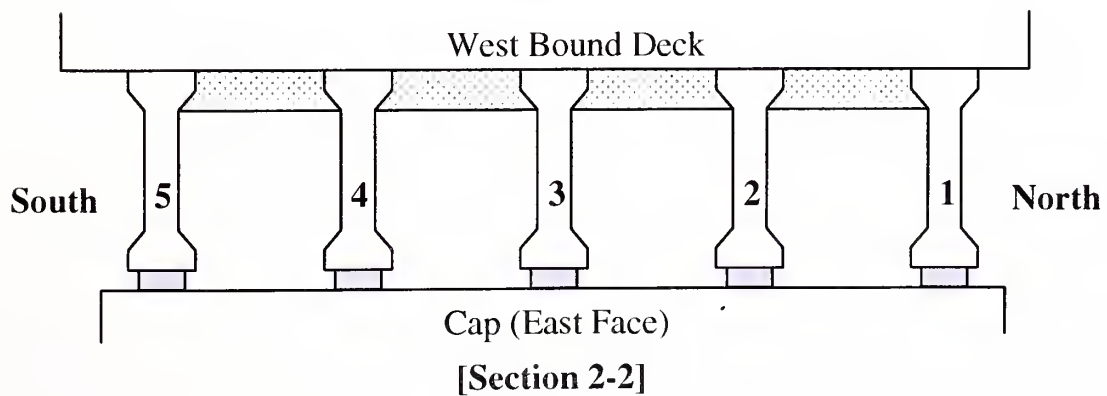
Figure 49B. Condition of Beam Joints over Bent No. 19 (West Bound).

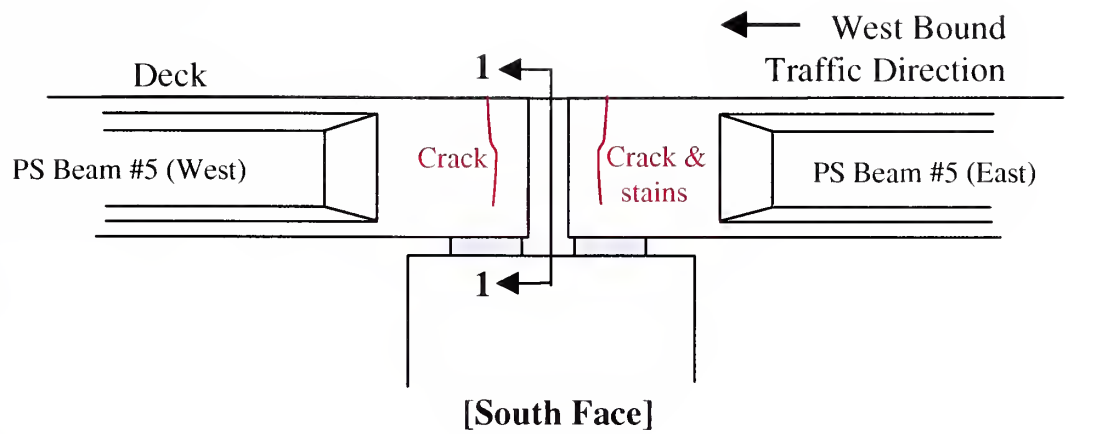
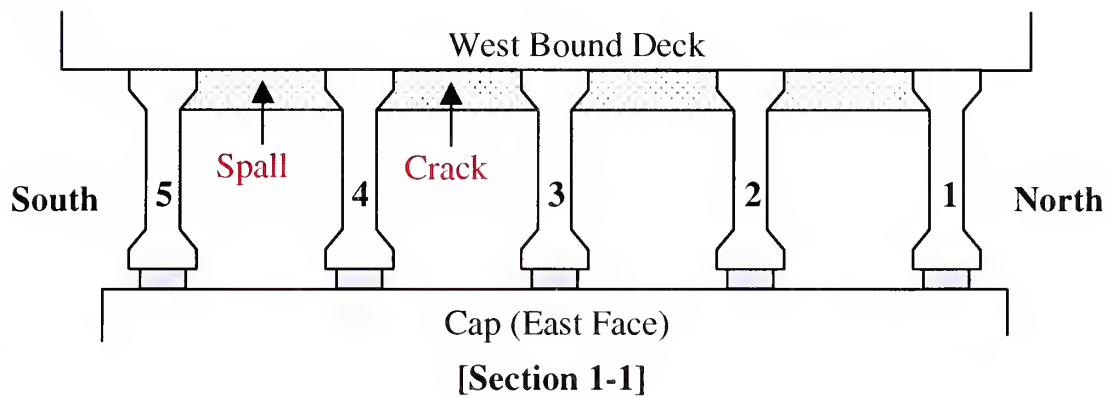
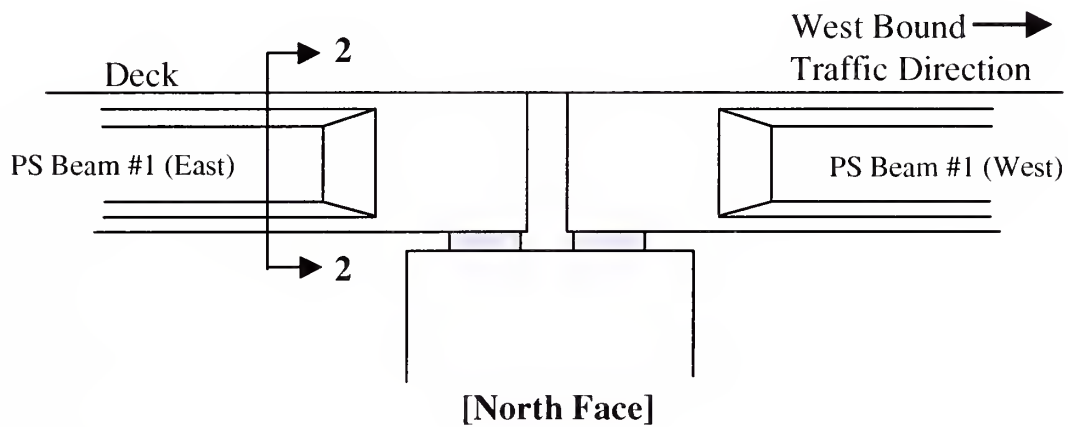
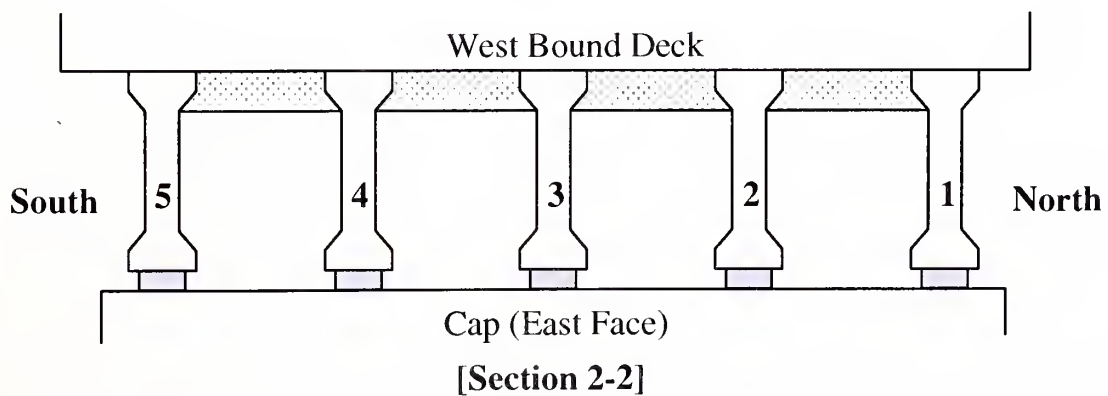
**Figure 50B. Condition of Beam Joints over Bent No. 20 (West Bound).**

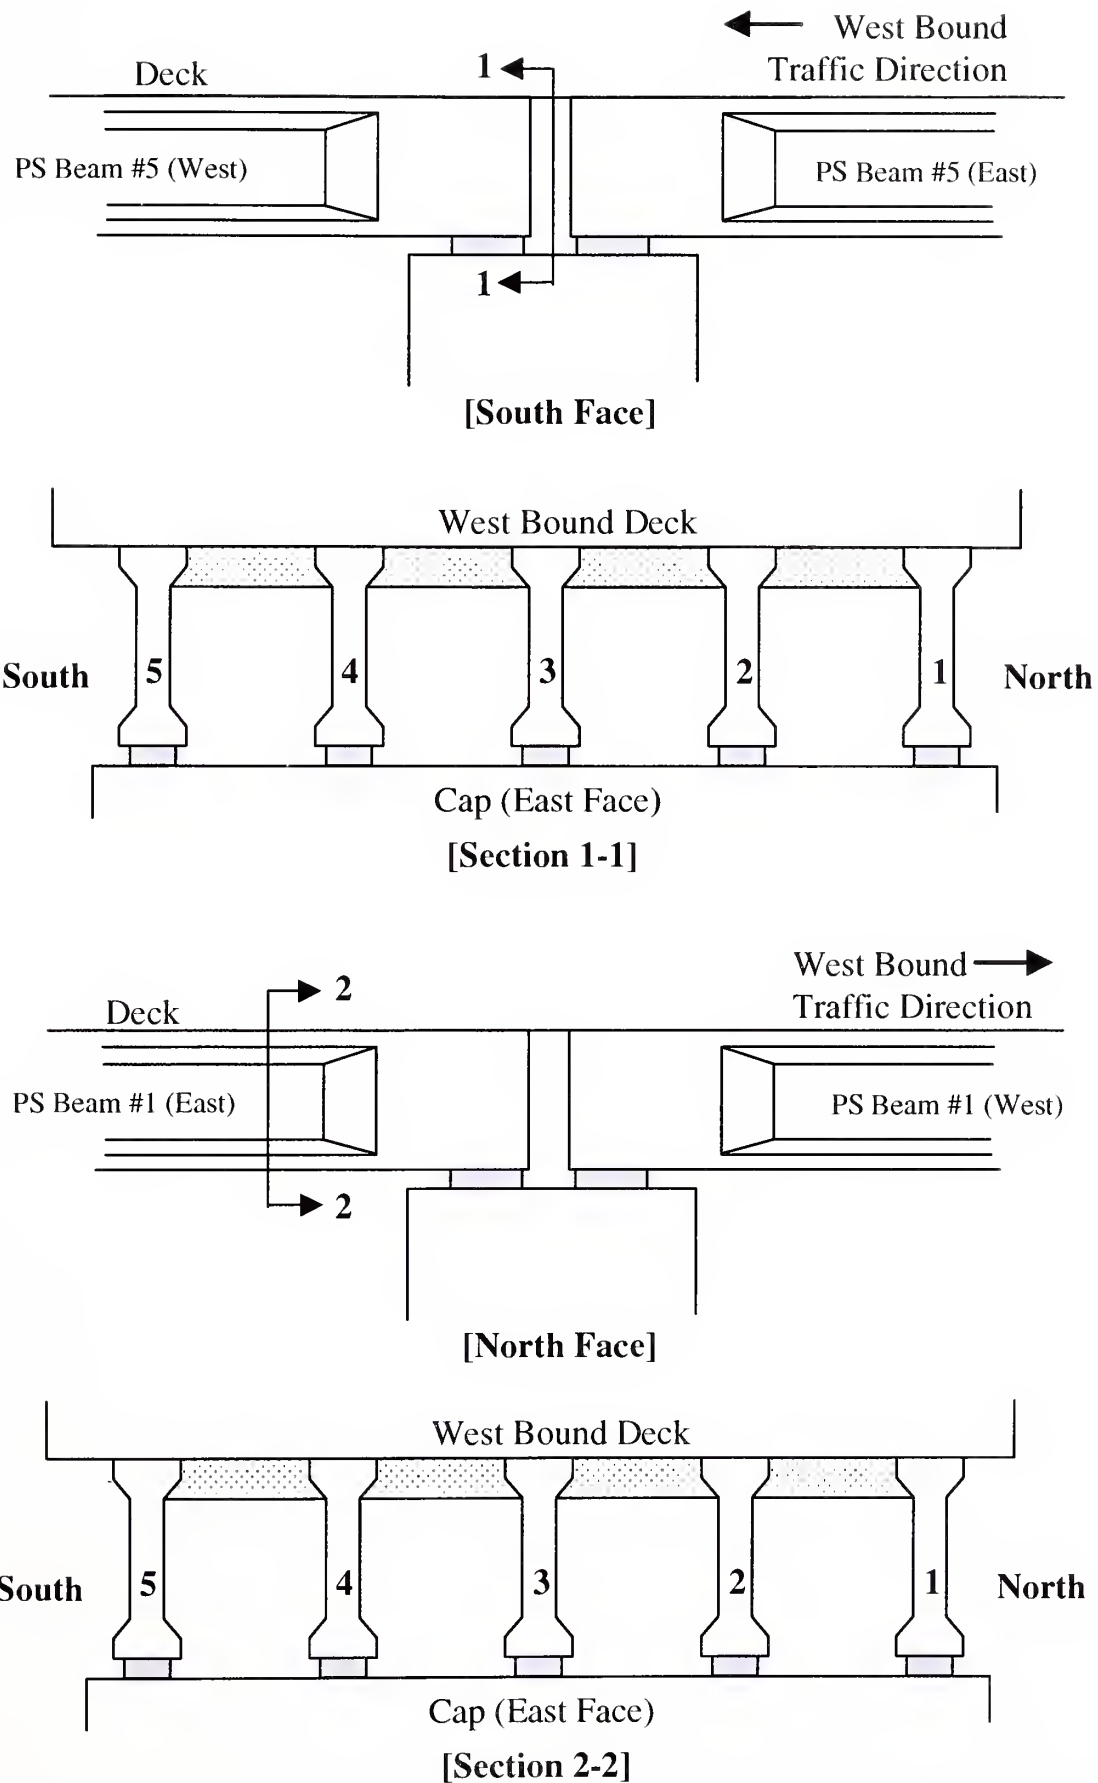
**Figure 51B. Condition of Beam Joints over Bent No. 21 (West Bound).**

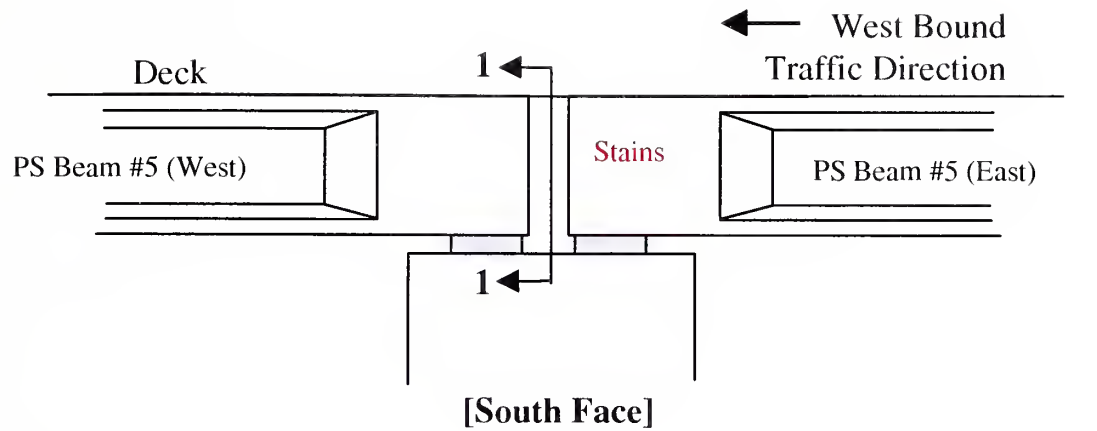
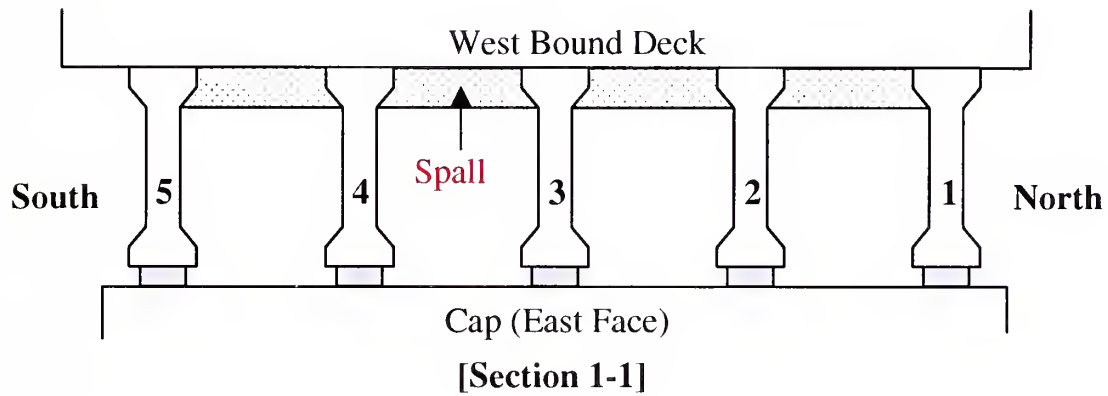
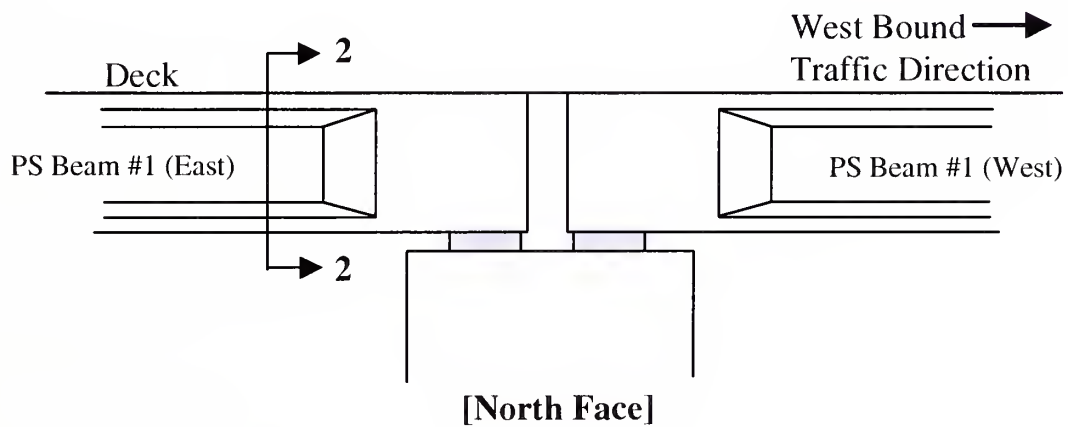
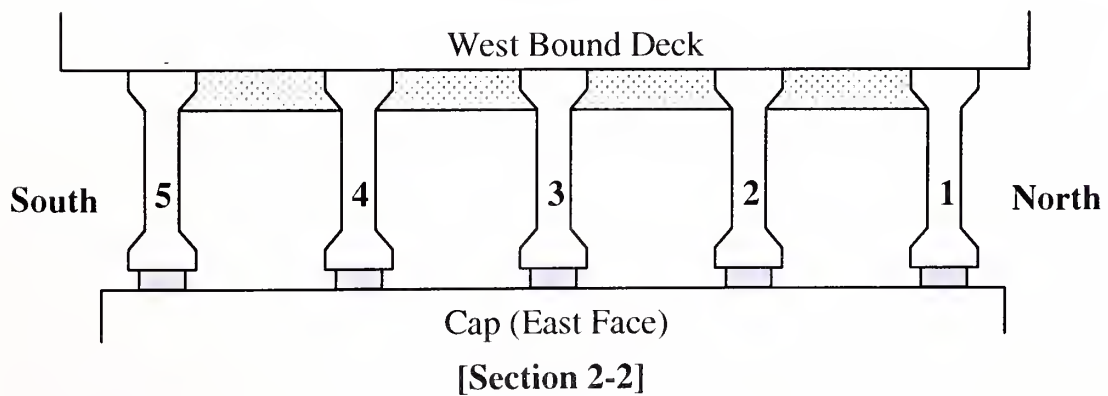
**Figure 52B. Condition of Beam Joints over Bent No. 22 (West Bound).**

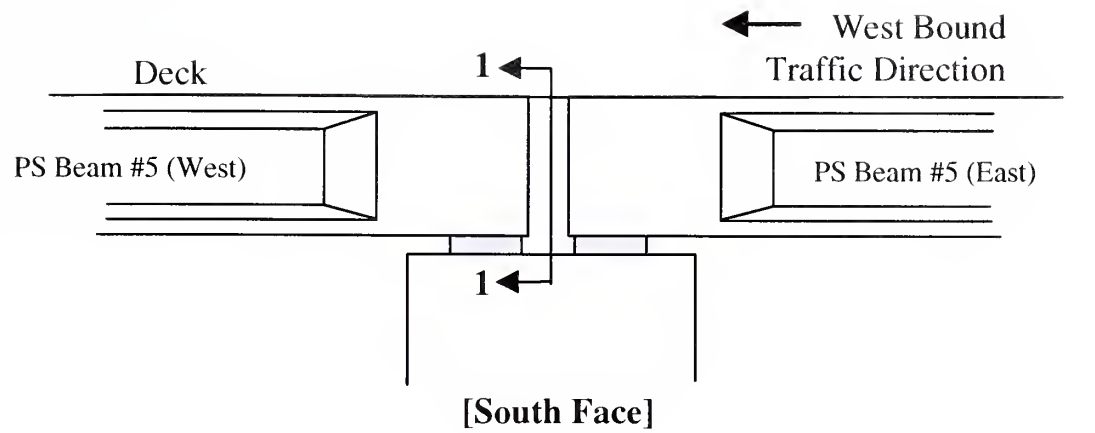
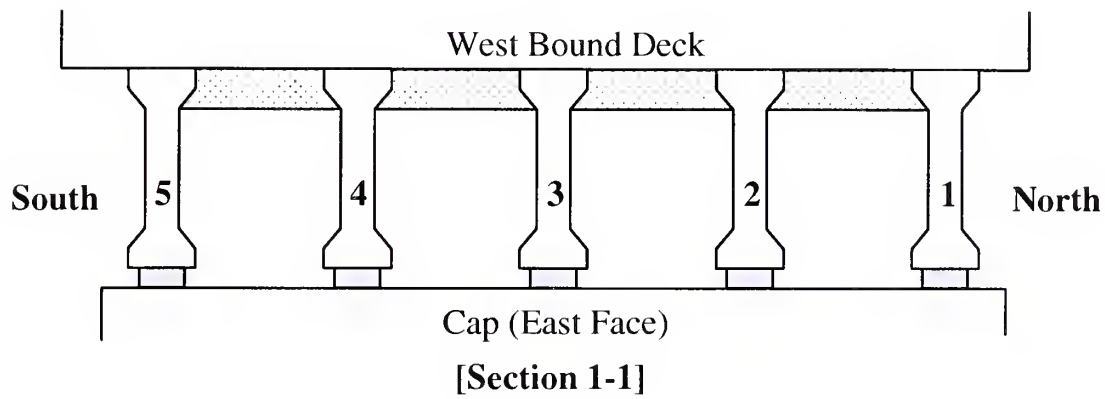
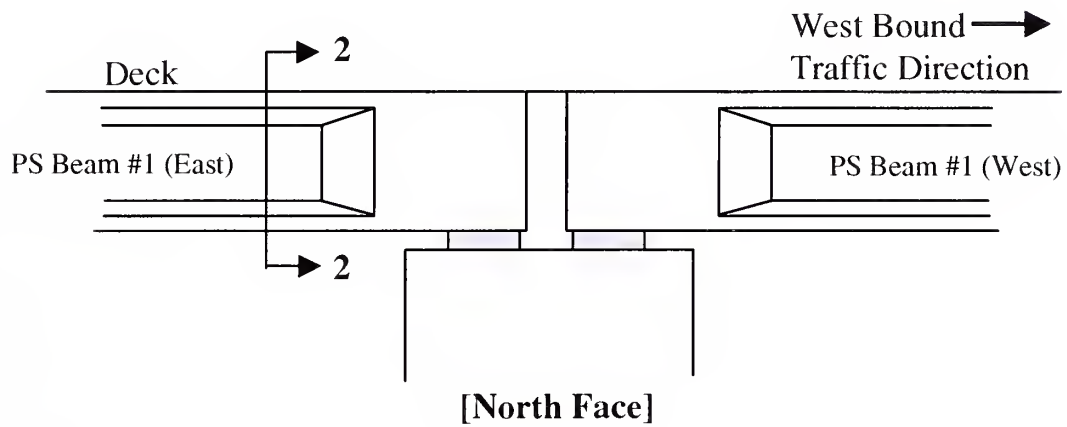
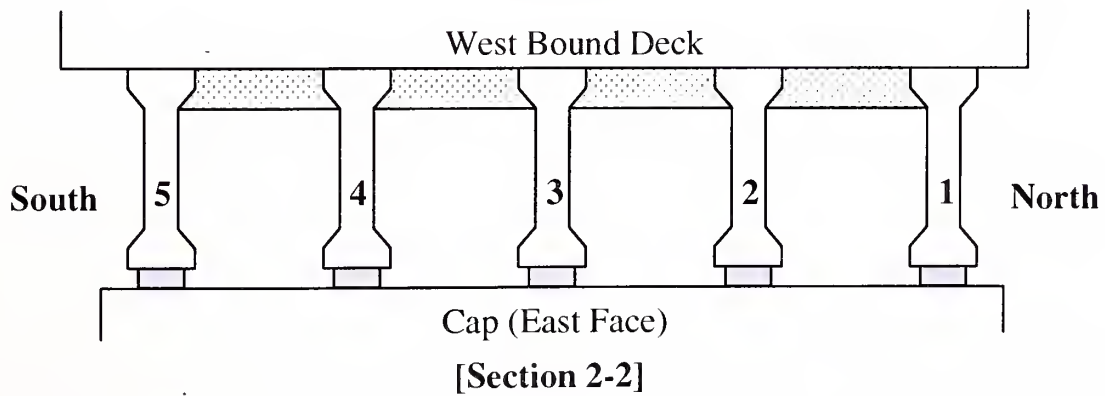
Figure 53B. Condition of Beam Joints over Bent No. 23 (West Bound).

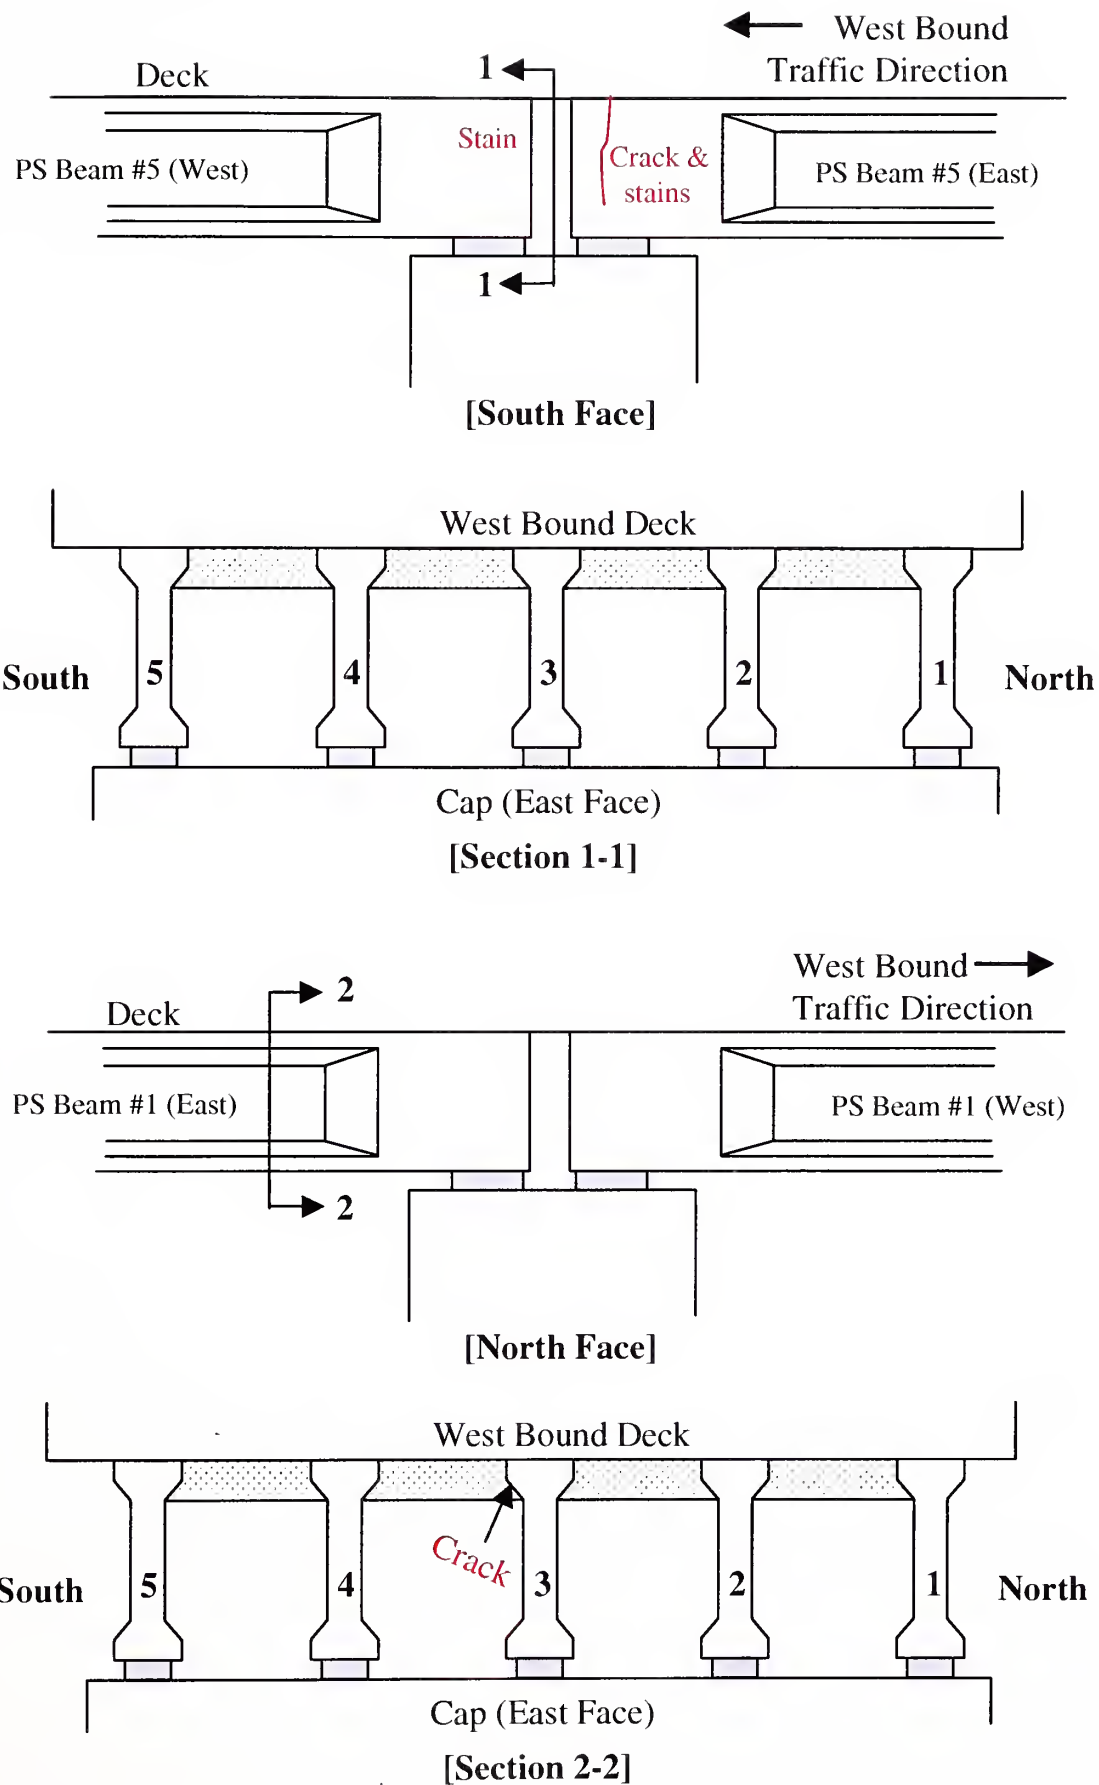
**Figure 54B. Condition of Beam Joints over Bent No. 24 (West Bound).**

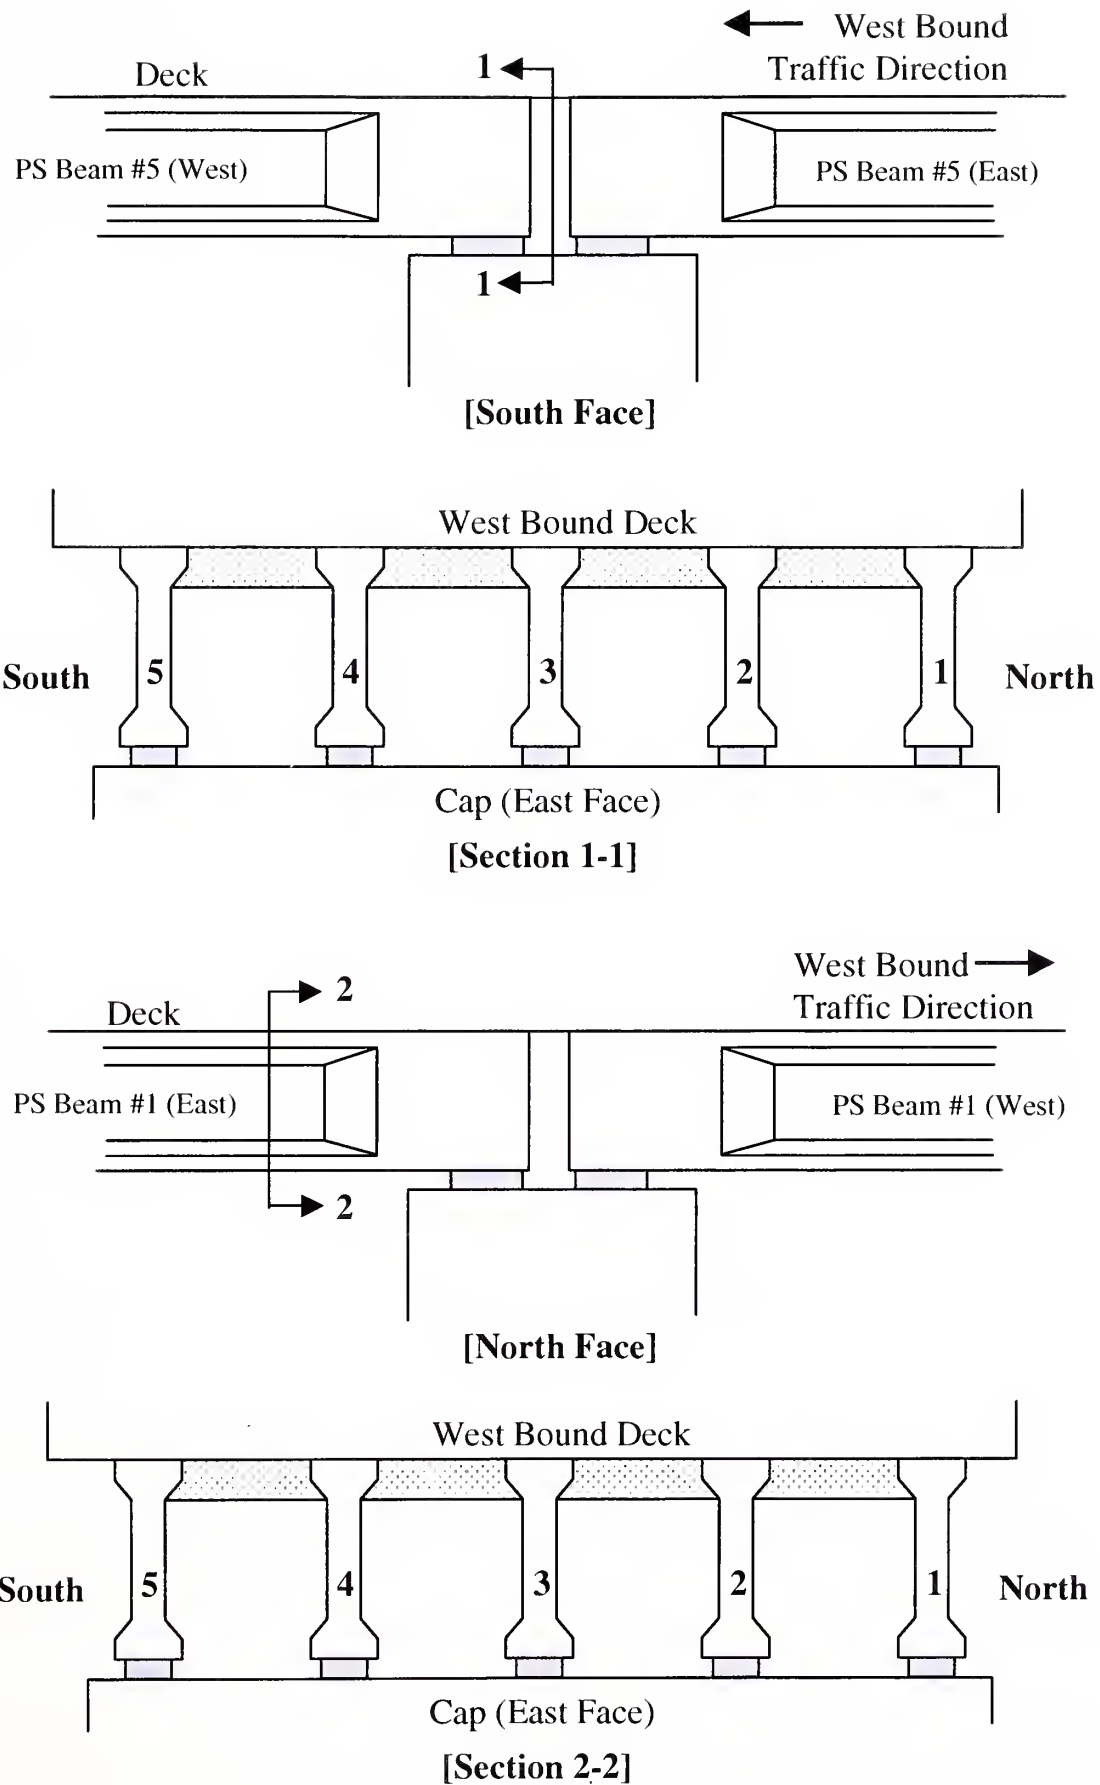
**Figure 55B. Condition of Beam Joints over Bent No. 25 (West Bound).**

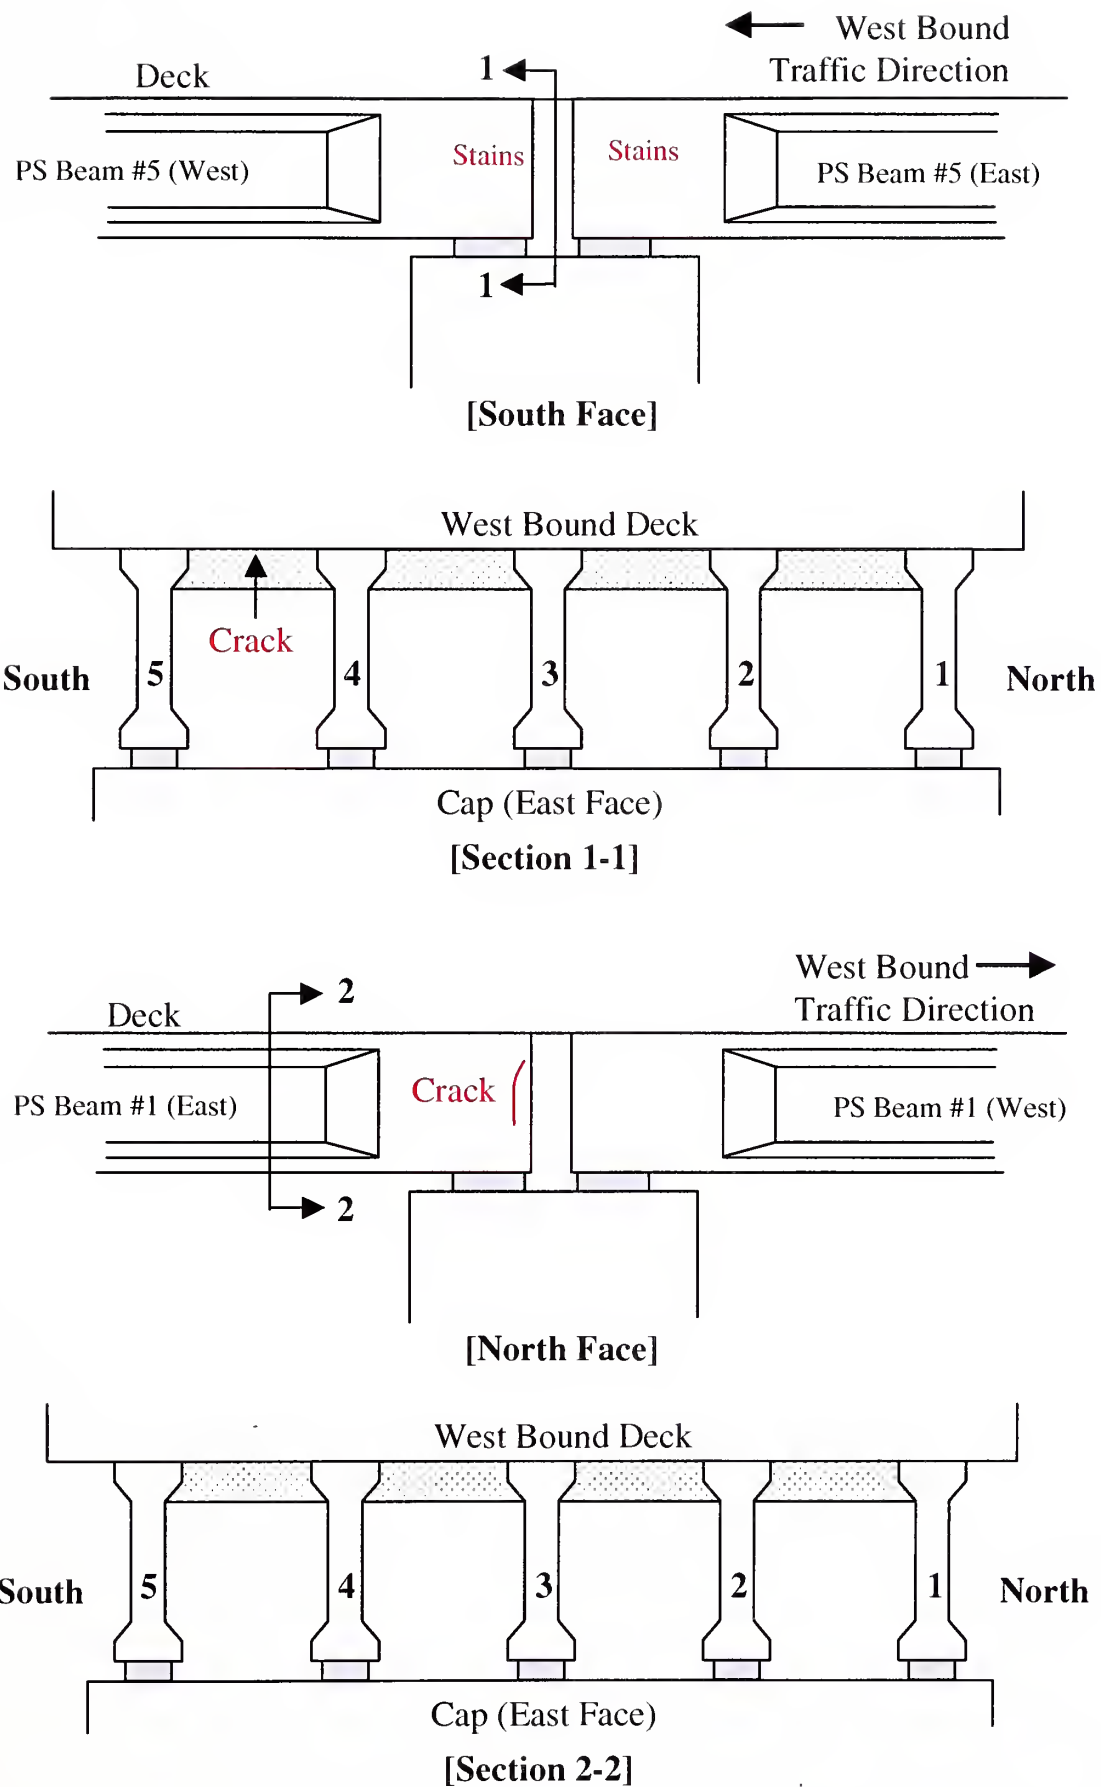
**Figure 56B. Condition of Beam Joints over Bent No. 26 (West Bound).**

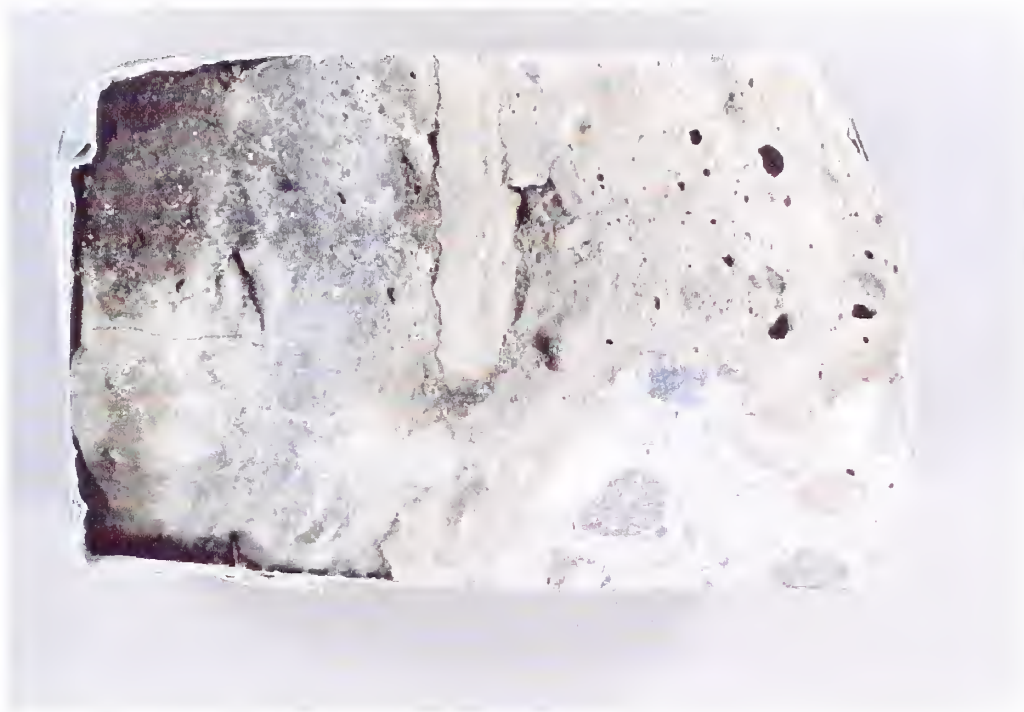
Fractures were detected on the top surfaces of all the cores. The fractures at the tops of Cores 4, 5 and 9 were approximately 0.075 inch wide at the surface where they had likely experienced some erosion. These fractures decrease in width to less than 0.010 inch or less at depths of 0.05 inch below the existing surface. The fractures in Core 5 and 9 extended the full-depth of the cores. Dirt and debris were detected all along those fractures (Photo 1). The fracture in Core 4 only extended 0.5 to 1 inch into the core, but dirt and debris were also detected along this fracture.

The observed cracks are very likely due to shrinkage of the cement paste. The deeper carbonated paste around the pre-existing fractures suggest that the fractures opened up over time. Dirt and debris were detected all along the fractures. The presence of soil along the fractures and the secondary deposits of ettringite in some of the air voids suggest that water is able to move easily throughout the concrete.

Photo 1: The fracture surface of Core 9 is shown. Dirt and debris are present all along the surface.

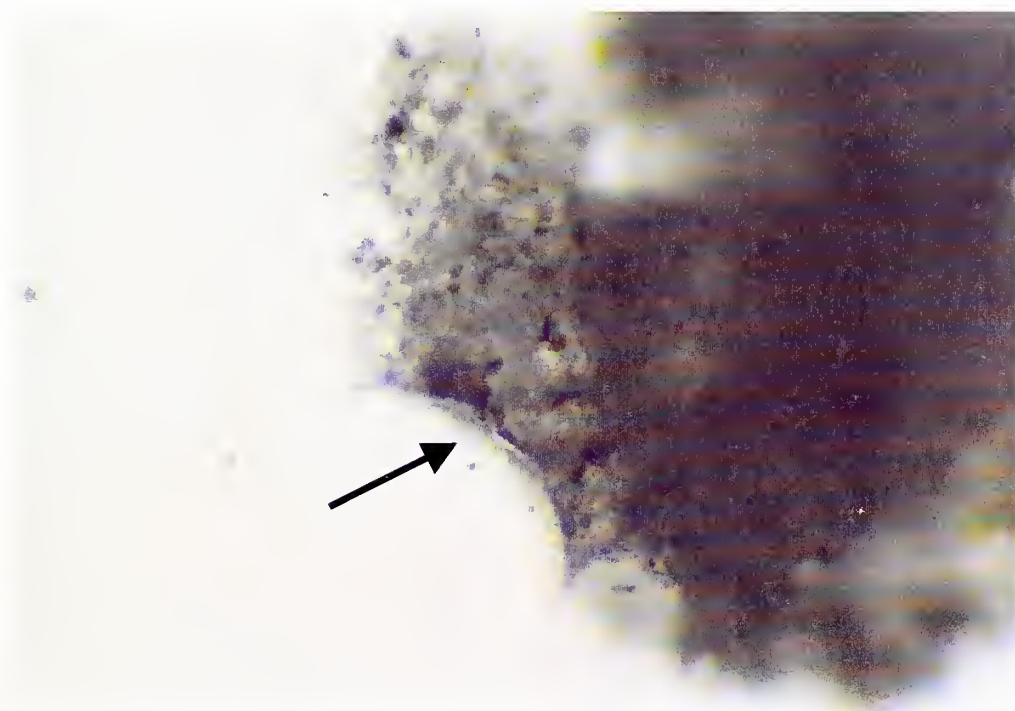
Photo 1: A grain mount of the cementitious material in Core 15 is shown. The arrow indicates ettringite needles, within an air void.
